Two-Dimensional Model Test Study of New Western Breakwater Proposal for Port of Hanstholm

DCE Contract Report No. 184

December 2016

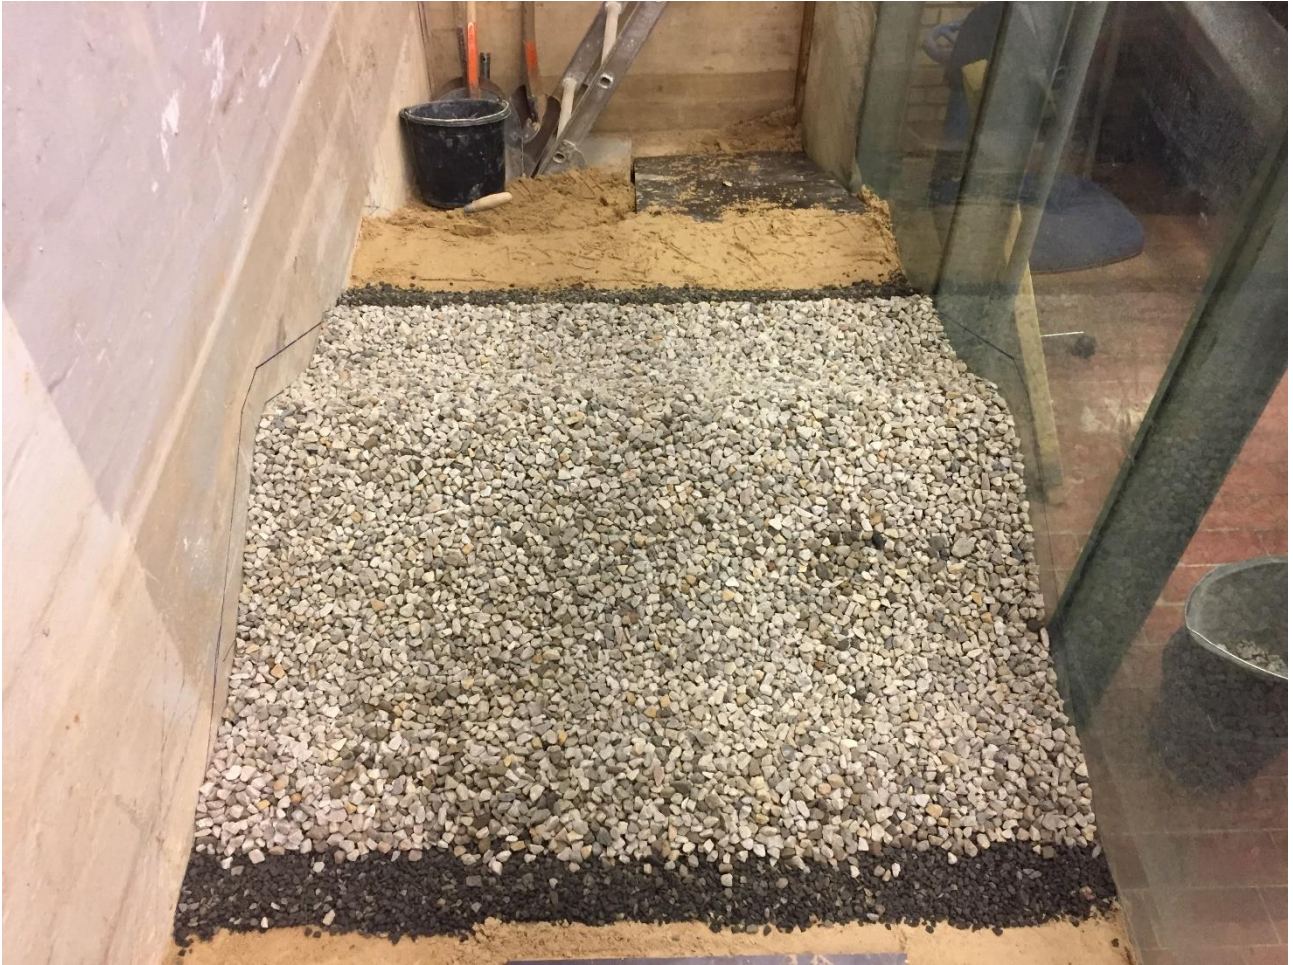
Figure 6: Breakwater with core and upper core for cross-section C1.

The phases of construction of cross-section C1 are shown in Figs. 6 – 8. A final setup of C2 can be seen in Fig. 19. The foreshore was modelled together with a section of the breakwater. The first 12 m of the foreshore was made of plywood and the last 1.6 m was made of fine sand with $D_{n50} \approx 0.17$ mm in model scale (chosen to avoid cohesive response). The armour stones were placed in two layers and profile was measured with the laser profiler to ensure that the averaged profile was a close match to the design profile given by the client.

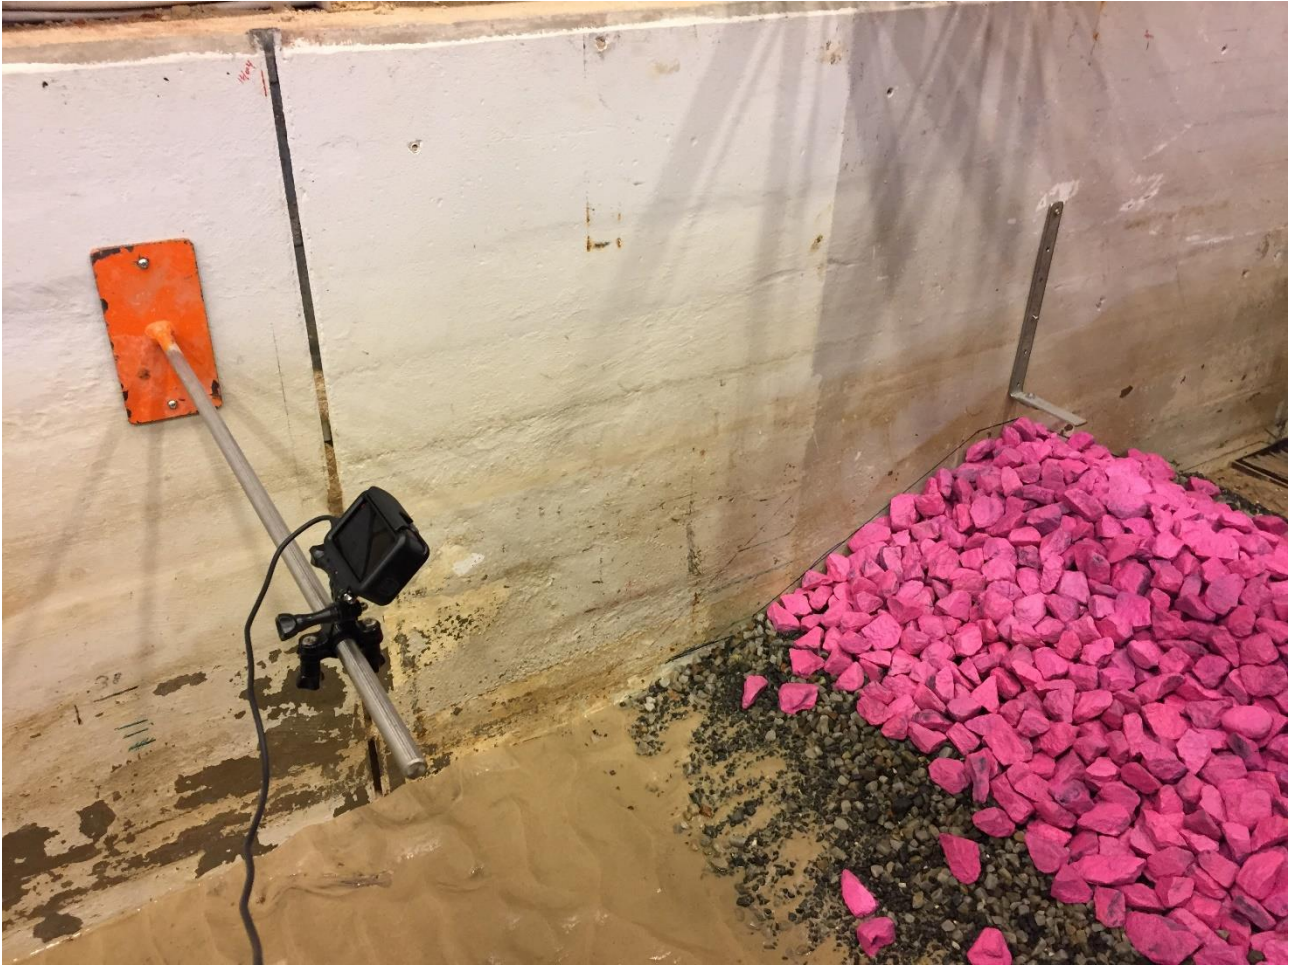
Figure 11: Camera in front of the breakwater, example with cross-section C1.

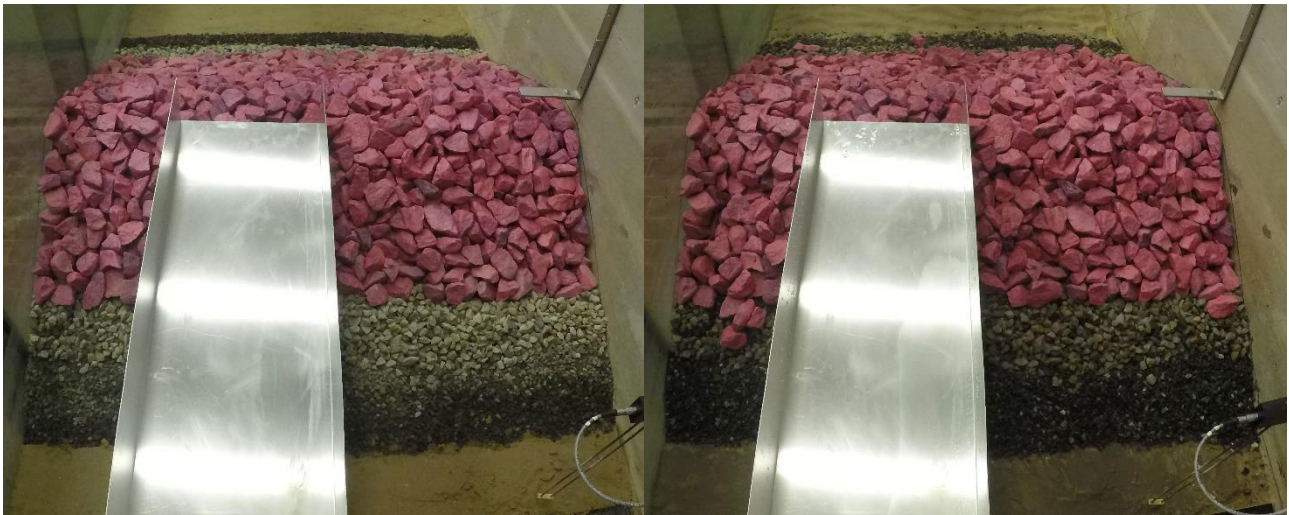
Figure 16: The rear of the breakwater (C1) is shown on both pictures. Left shows before test 1 and right shows after test 3.

The damage to the rear side can be observed by comparing photos in Figs. 16 – 18. Damage could be observed after the 1 year events, but some damage is expected as the stones will settle when first exposed to waves/overtopping flow, cf. Fig 16. The damage increased after the 10 year events and could have been more severe if not the overtopping ramp protected the rear side as seen in Fig. 17. The damage after Test 11 is shown in Fig. 18. Some localized holes start to appear due to damage from high overtopping. However, the observed damage seems acceptable but some repair works must be expected after significant storms.

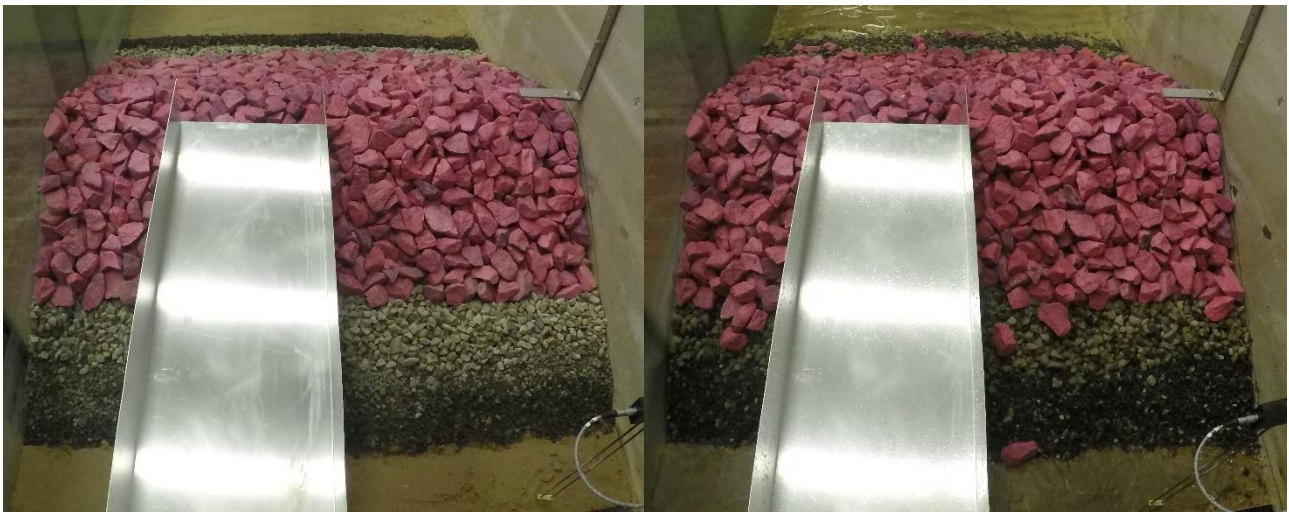
Figure 17: The rear of the breakwater (C1) is shown on both pictures. Left shows before Test 1 and right shows after Test 6.

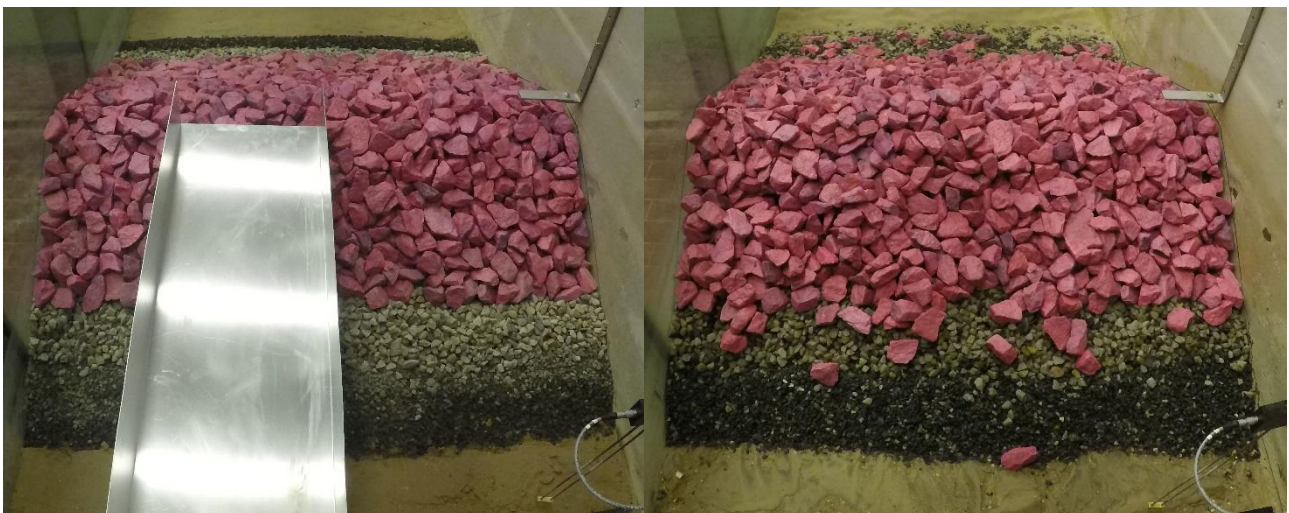
Figure 18: The rear of the breakwater (C1) is shown on both pictures. Left shows before Test 1 and right shows after Test 11.
